Use of American Lotus in Pond Remediation

Adam S. Riazi, Mathematics Department, Lincoln County High School, WV and
 Michael G. Ryon, Environmental Sciences Division, Oak Ridge National Laboratory, TN

P-1 Pond Remediation Project

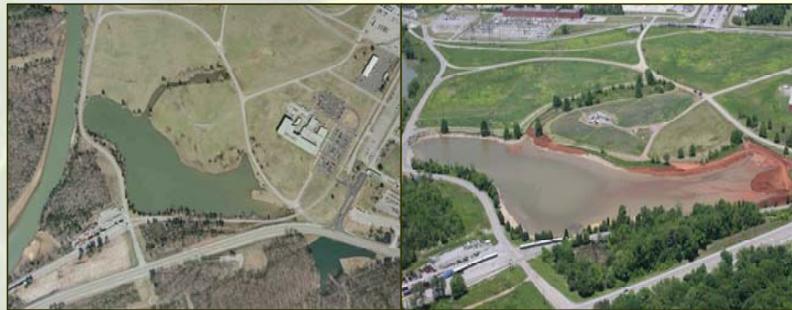
P-1 Pond March 2006

P-1 Pond May 2009

The P-1 pond remediation project is a large scale community remediation effort to study restoration activities associated with native grass communities, wetland and pond remediation, and riparian buffer establishment for a pond system located at the East Tennessee Technology Park (ETTP) site. The trophic structure of the pond system is being re-engineered by converting the system from a plankton-dominated system to a macrophyte-dominated system and changing the food-web from a planktivorous, bottom feeder dominated community (i.e. shad, carp) to a community of mid-water feeders (i.e. sunfish, mosquitofish). This is expected to create a more ecologically stable system that will have a lower flux rate of Poly-Chlorinated Biphenyls (PCBs) from the sediments up into the food-web, thereby lowering the ecological risk. The work includes lowering the water level in the pond, Rotenone elimination of fish communities, restocking of desirable fish communities, invasive plant treatments, culture and planting of native wetland and emergent plant species, including American Lotus (*Nelumbo lutea*) culture and planting.

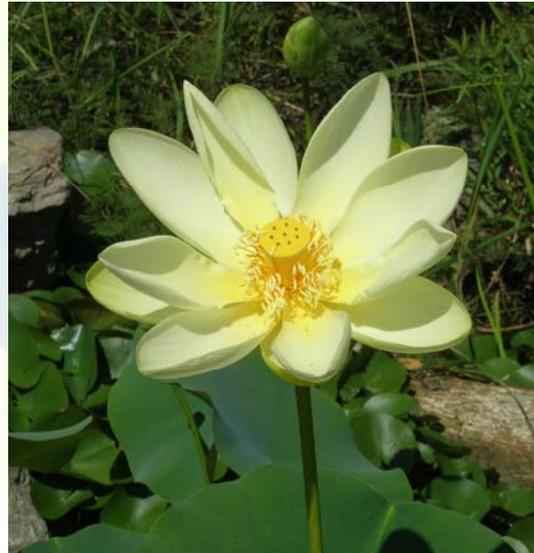
American Lotus (*Nelumbo lutea*)

The American Lotus is a perennial, flowering, aquatic herb. It is found in shallow water in ponds, lakes, sluggish streams, and marshes from Massachusetts to the Gulf of Mexico, throughout the Mississippi Valley, to the Great Lakes. American Lotus is recognized for its floating and emergent, large, round leaves, up to 60 cm in diameter. It also possesses a distinctive bright yellow flower, up to 25 cm in diameter. Its leaves and flowers arise directly from its rhizomes. Its seeds are round, hard, and nut-like, contained within a light spongy structure, normally requiring either scoring or animal digestion for germination. Native cultures baked the large roots like sweet potatoes, ate the leaves like spinach and the seeds were prepared to be eaten like nuts or ground into flour. The American Lotus can have a lifespan in excess of 20 years.

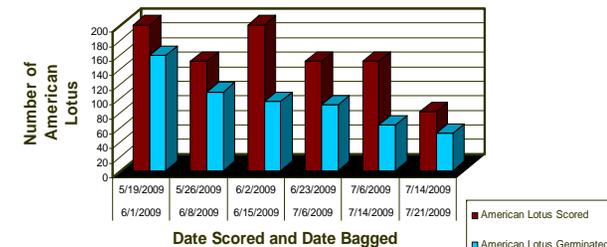
American Lotus Germination

Lotus Culture and Germination Results

Throughout the summer of 2009, a total of 931 American Lotus seeds were scored and soaked for germination. Of those 931 scored seeds, 565 germinated sufficiently to warrant planting in burlap bags, and then were allowed to mature in living stream tables. The 61% germination rate of the American Lotus seed is expected to increase over the next two summers as the project continues due to better and more selective seed sourcing, modification of culture and germination techniques, and an accelerated timetable for planting at the P-1 pond itself.

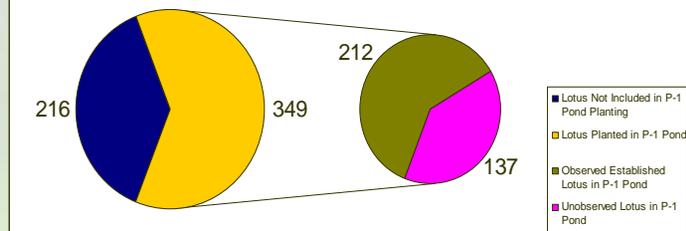
American Lotus Planting and Establishment in P-1 Pond

Lotus Planting and Establishment Results

Throughout the summer of 2009, a total of 349 American Lotus were planted in the P-1 pond. Of those 349 American Lotus planted, 212 were observed to have established themselves through further growth and through increased leaf size and number. The 61% success rate of establishment is expected to increase over the next two summers through the utilization of more cage planting, the relocation of geese who use the lotus as a food source, and through the use of healthier, more mature lotus plants in the future.

We also expect to see a lower PCB flux rate and bio-accumulation in the P-1 pond due to the root structure and rhizomes of the American Lotus binding the soil, locking the PCB contamination in place, in addition to the other remediation and restoration efforts used to repair the P-1 pond system, thereby, significantly reducing the ecological risk.
